A picture taken of the Lighthouse and the Keeper Quarter as existed from 1884-September 28, 2022

To provide you an update today I'd like to first provide you with the pictures that show the destruction that Ian did to our Lighthouse site.

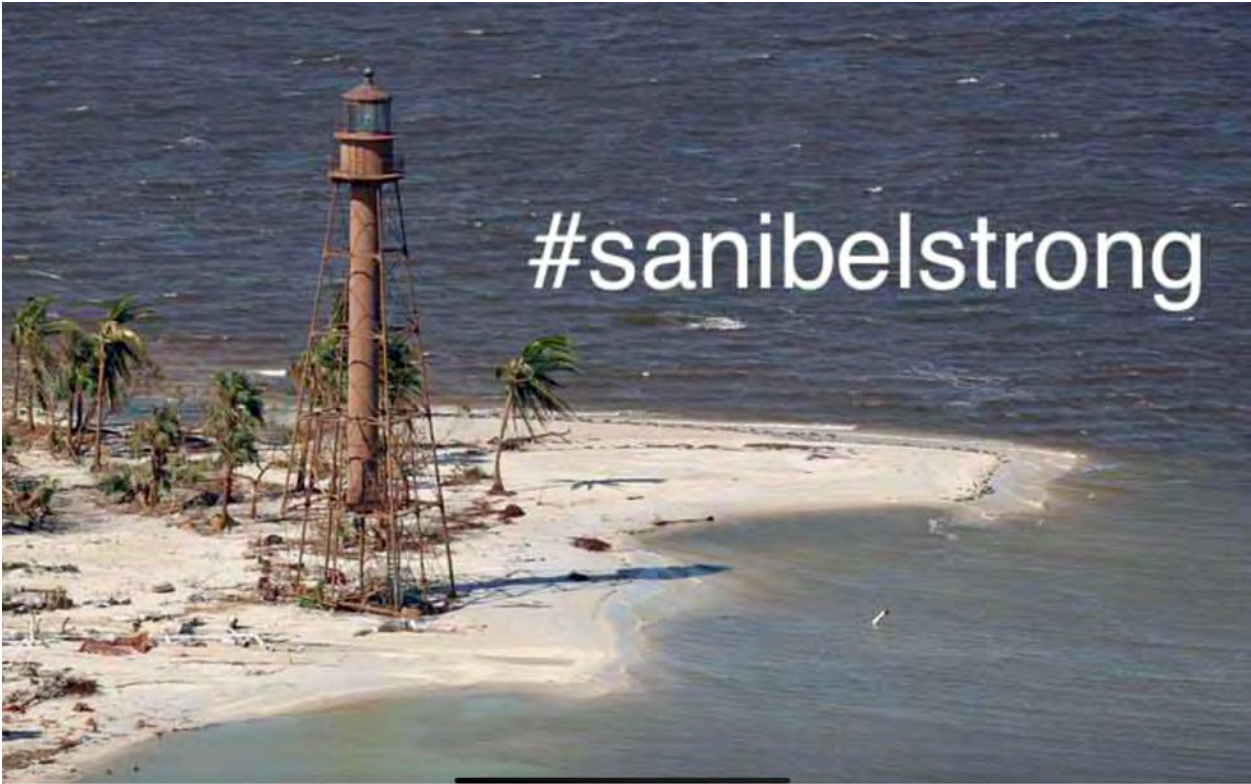
(2)

As you can see no Keeper Quarter Houses exists anymore other than some foundation rubble, bricks and cast iron piling. It is confirmed that when the 12 foot storm surge hit it lifted the Keeper Quarters and their cast iron foundations out of the ground and hurdled them toward the base of the tower and broke the bottom part of one of its columns or "legs" as they are known.

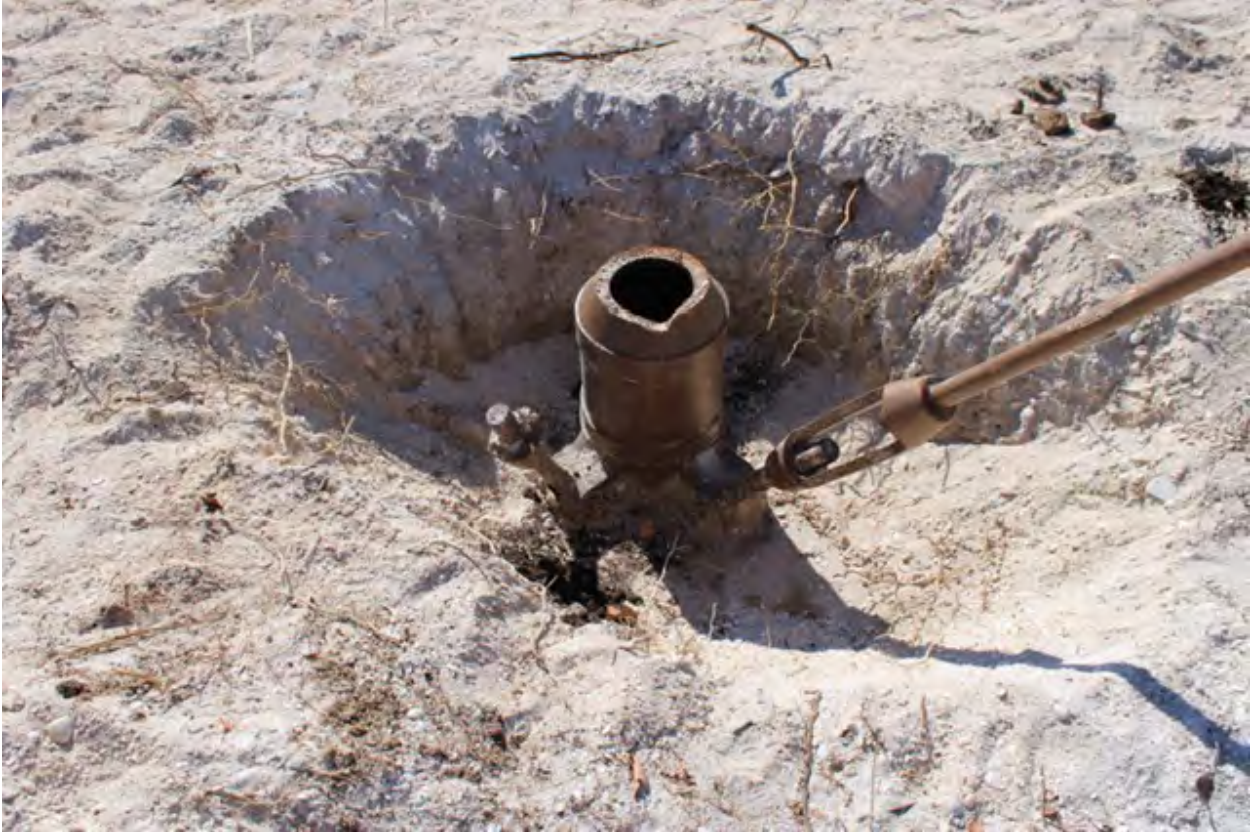
(4)
The main support columns at the northwest corner of the tower indicating how it was sheared off at its connection point.

If it had not been for the structural concrete footings on each of the other columns at their base which we think was added at the turn of the century,

or as the legend says the legs are cross bracing at the base of the Tower, the Tower would have come down.

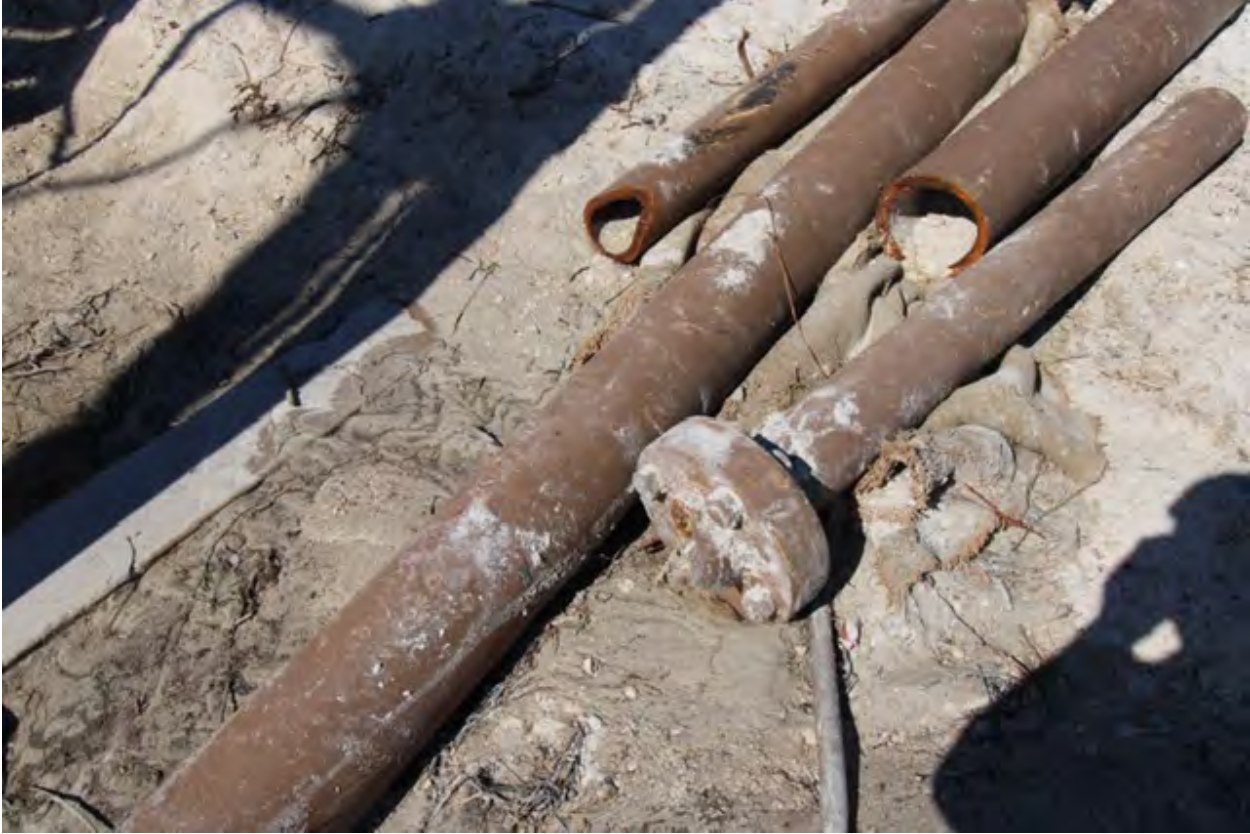
(5)
The column portion broke in three places which sits at the base of the Tower waiting to be copied and reconstructed.

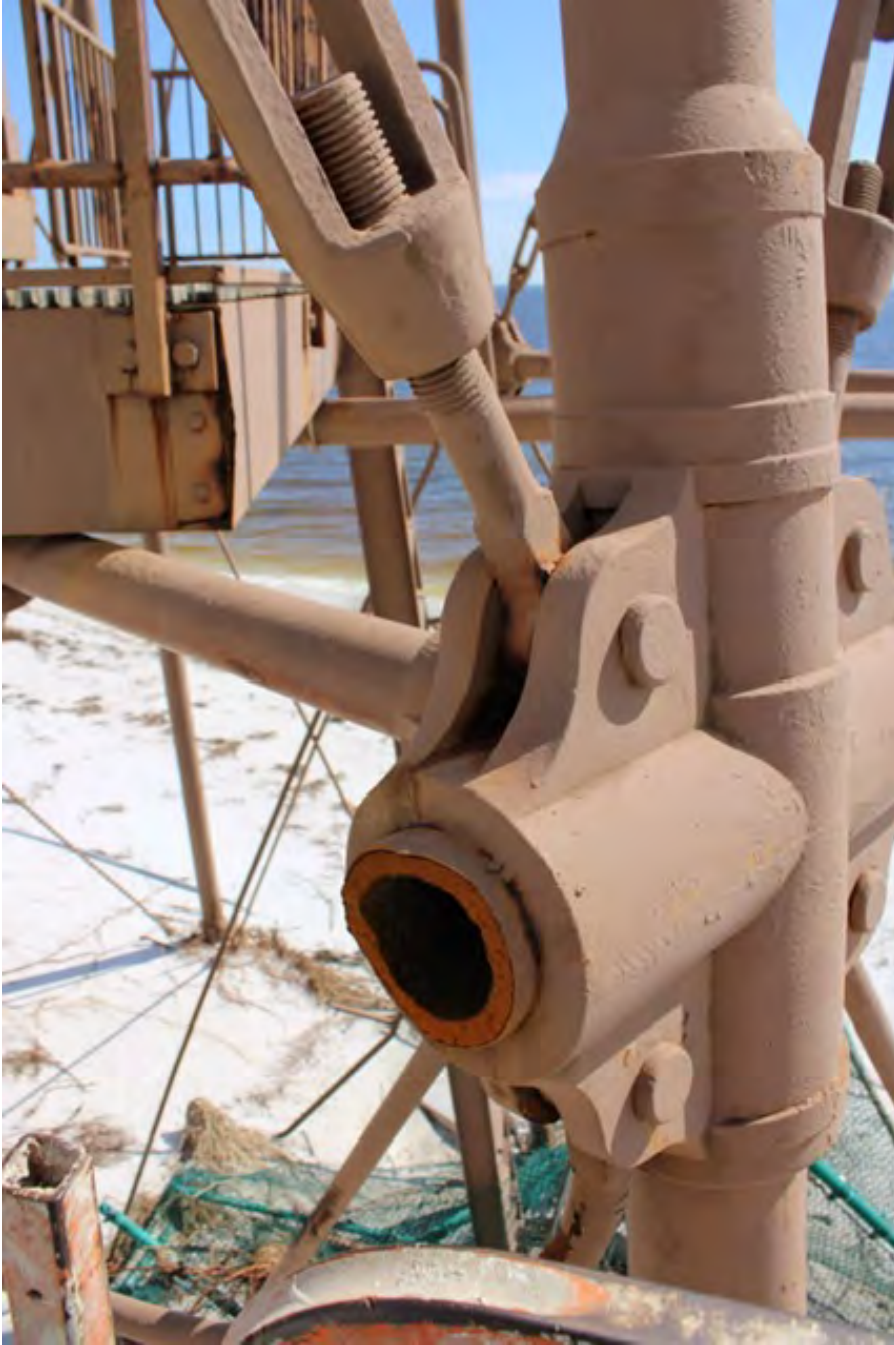
(6)
The cross bracing was also sheared off which will need repairing to stabilize the Tower.

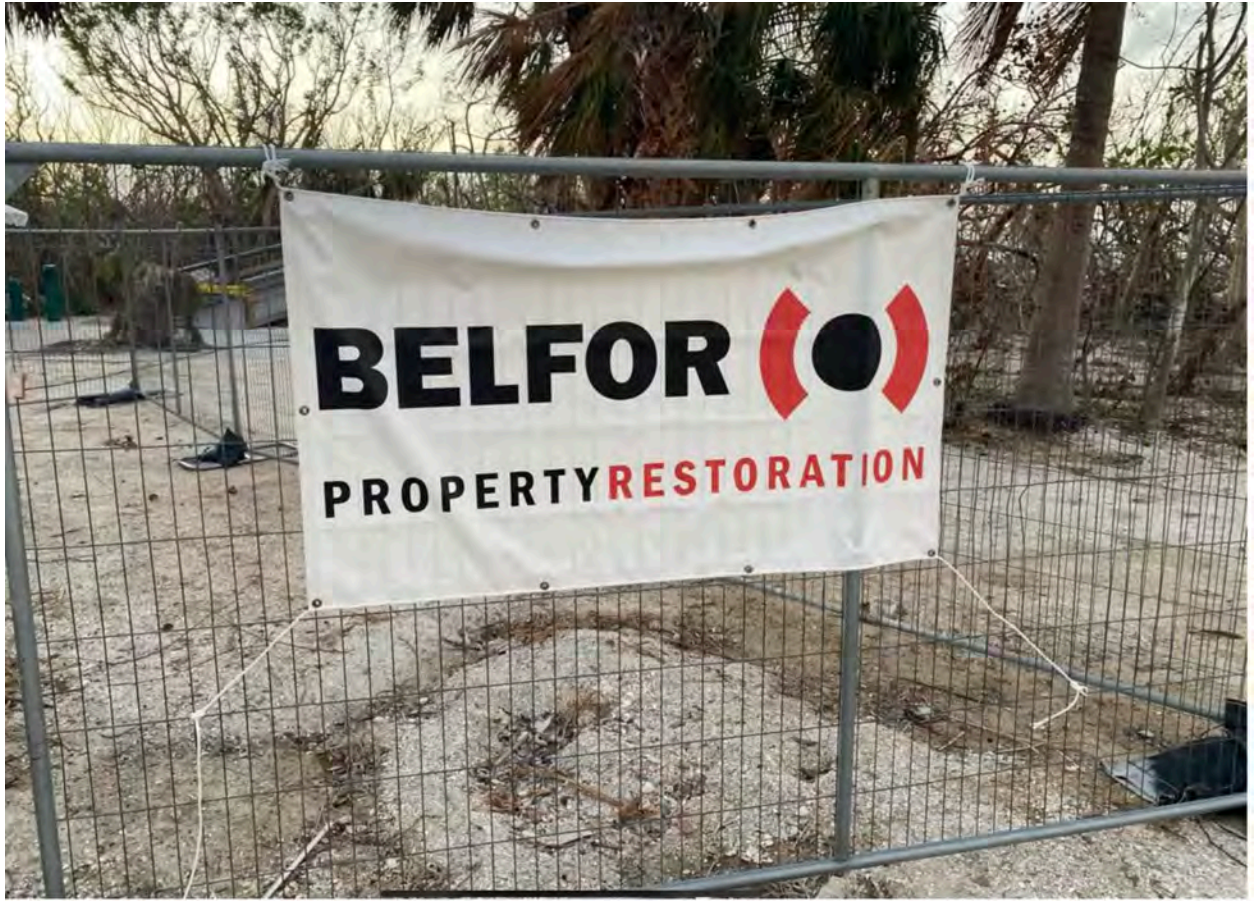
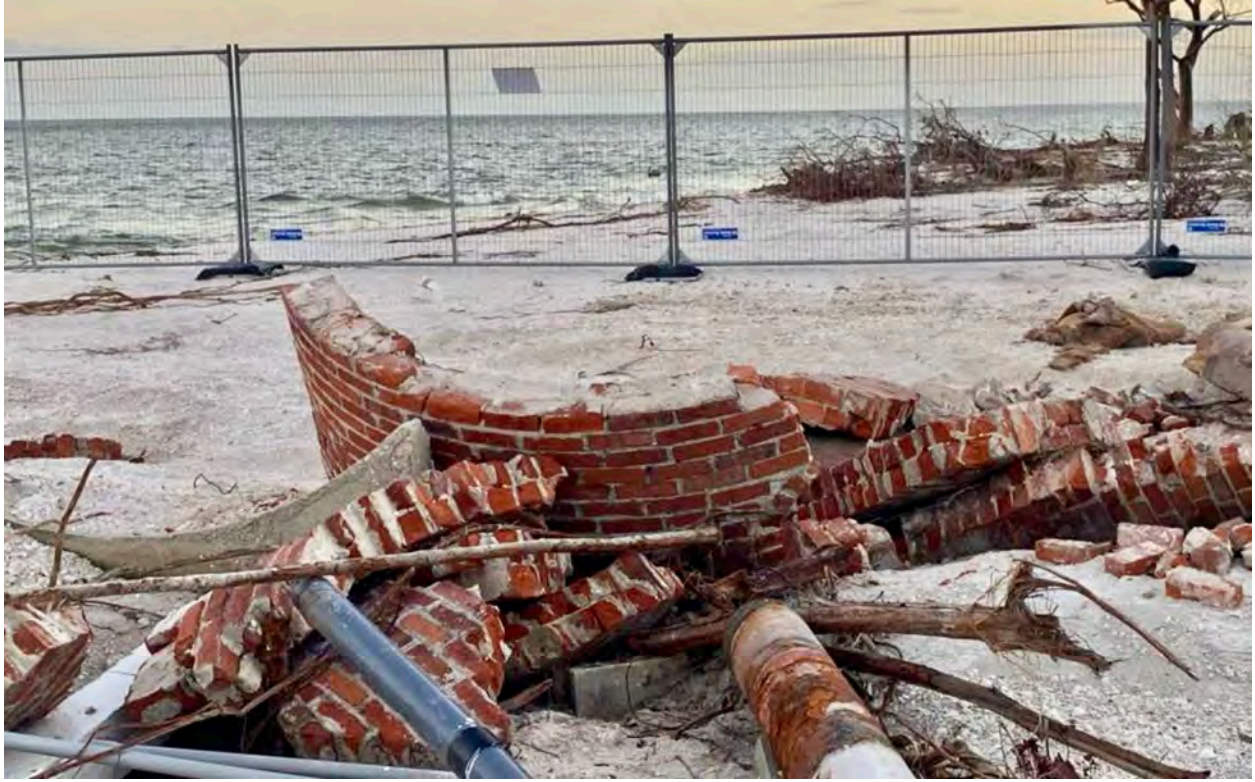
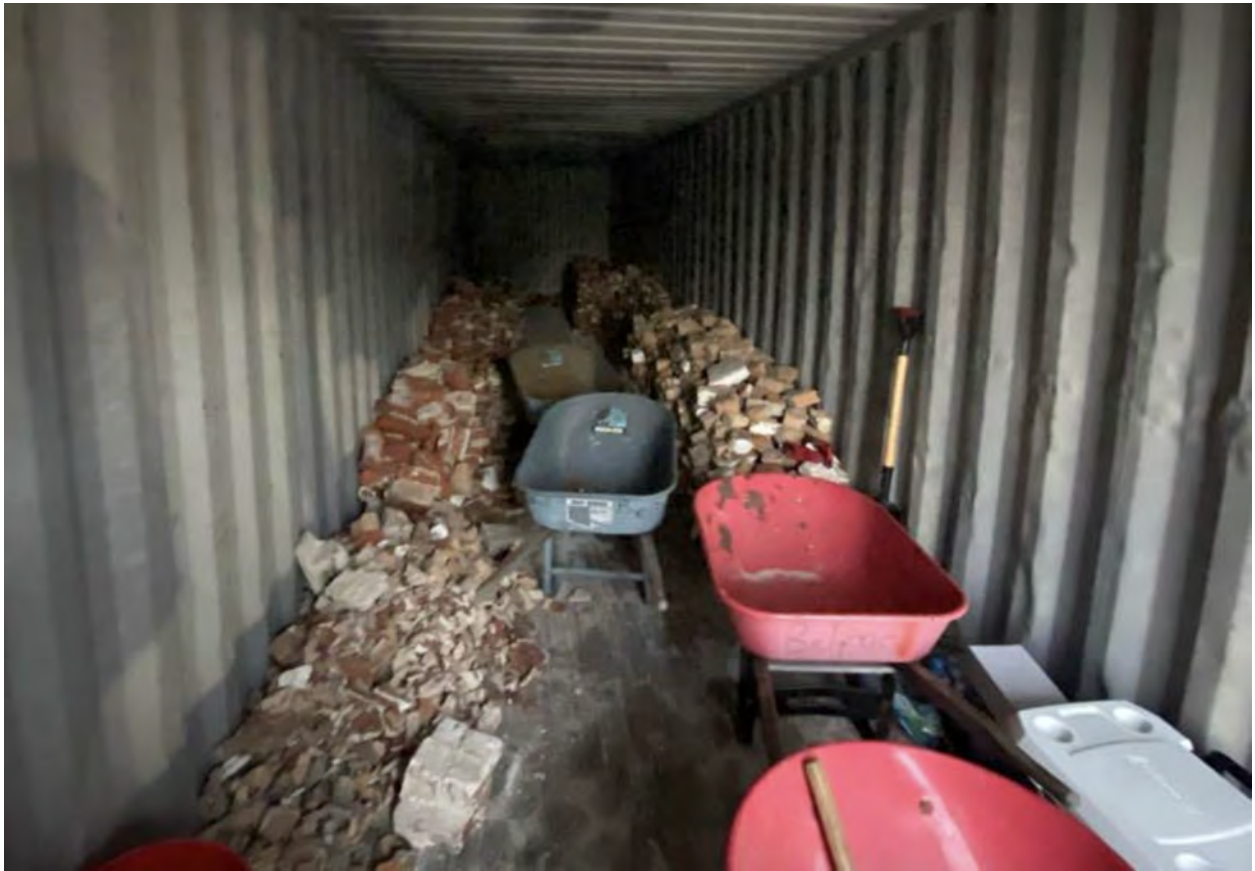
Pictures (10) (11) (12)

The Insurance and collaborative restoration company Belfor acted quickly to secure the Lighthouse site to avoid any vandalism which started to happen. Bricks were being taken off the site that could be used in the future to rebuild the Keeper Quarters or act as historical reminders of what was there originally.

This is a container that is salvaging the bricks that were either parts of the wonderful central heating Keeper Quarter chimneys or the cooking chimneys at either end of these buildings.
